VELOCITY AND ABRASION STUDIES OF  
ARMCO SMOOTH-FLO PIPE--SARGENT CANAL  
MISSOURI RIVER BASIN PROJECT, NEBRASKA

General Report No. R20

Subject: Velocity and Abrasion studies of Armco Smooth-flo pipe--  
Sargent Canal--Missouri River Basin Project, Nebraska

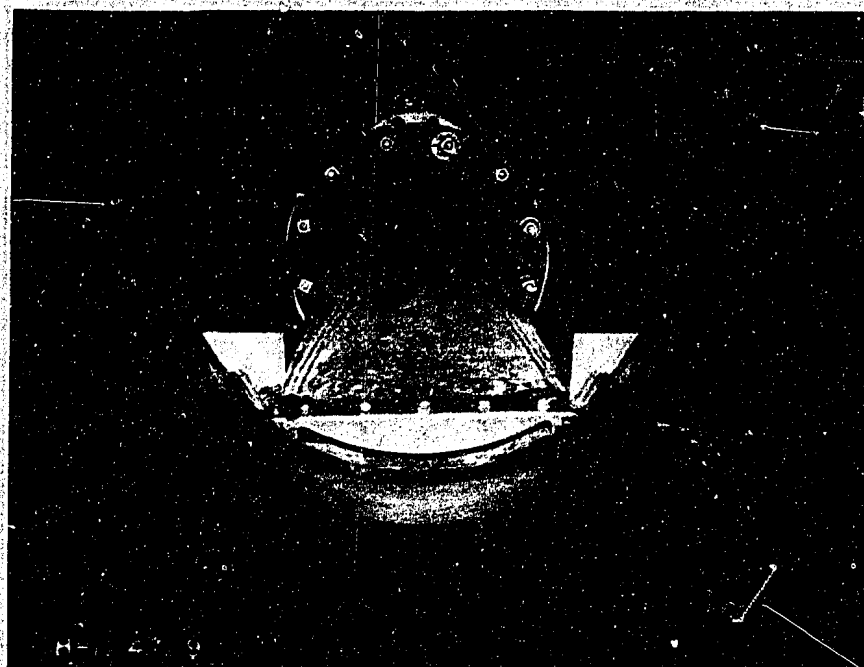
In a total time of 12 hours and 45 minutes the largest piece of coating was removed near the right-hand end of the eroded area,

Figure 4A and B. This piece, Figure 4B (Detail A), measured 1-3/4 inches along the nozzle and 1-11/16 inches downstream from the nozzle exit. Inspection of the piece disclosed that the water had raised the upstream edge into the flow and then peeled the piece in a downstream direction as the projected area increased. The final break of the piece from the coating gave the appearance of flakiness and left a rough edge at the downstream end of the hole.

**A. Erosion after total time of 12 hours-45 minutes  
at a velocity of 30 feet per second**

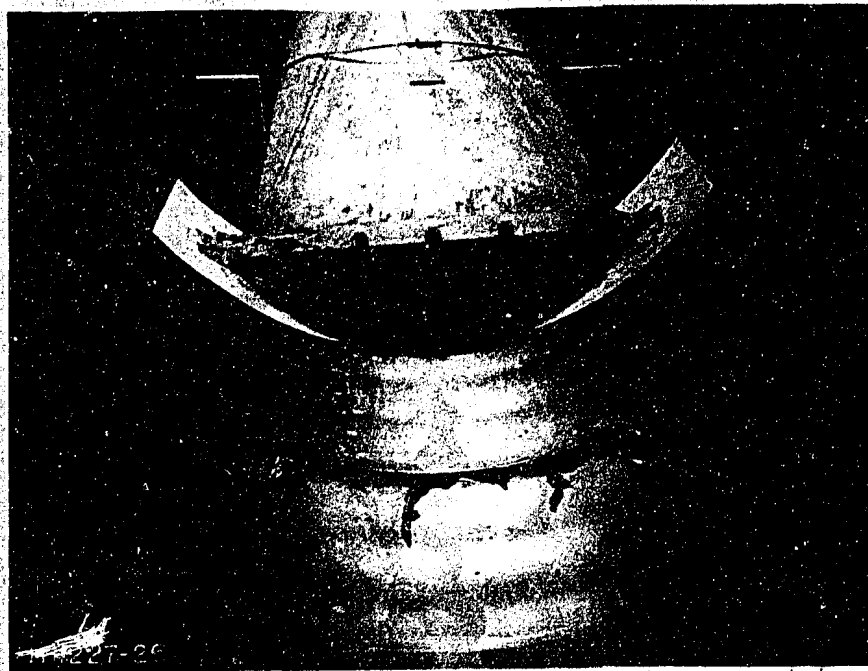
For a comparison with the results of the test on the unfilled joint, the filled joint test was continued for a total time of 30 hours. An additional small amount of filler was removed from the joint (Figures 7 and 8). A small amount of damage to the pipe was discerned on the ends of both the upstream and downstream pipe sections. On the end of the upstream section a small piece of coating 1/4 inch long by 1/16 inch maximum in width had been torn from the pipe to remain attached to the filler. The bond between the filler and coating was apparently stronger in this small area than the strength of the asphalt. Very slight damage to the end of the pipe forming the downstream side of the joint was also caused by a tearing action. In the 30-hour test period there was no apparent erosion caused by direct water impingement on the end of the pipe as had occurred in the test on the unfilled joint. The filler bridged the joint and deflected the water away from the exposed end of the downstream pipe to prevent the erosion. Thus, the filler may offer protection provided it is not torn from the joint to expose the ends of the pipe.

**A. Joint appearance after total test time of  
30 hours at a water velocity of 30 feet per second  
compare slight change with Figure 7**

A curing period longer than the 48 hours previous to the laboratory test would increase the resistance of the filler to the velocity and could increase the bond strength between the filler and coating. The manufacturers usually recommend 7 to 10 days curing. The increased strength of the filler and coating-filler bond should provide protection of the joint provided the filler does not project appreciably into the pipe. If the filler projects into the pipe to provide a leverage for the flow of water, chunks of filler and coating could be torn from the pipe. This action would expose the pipe ends to further erosion.

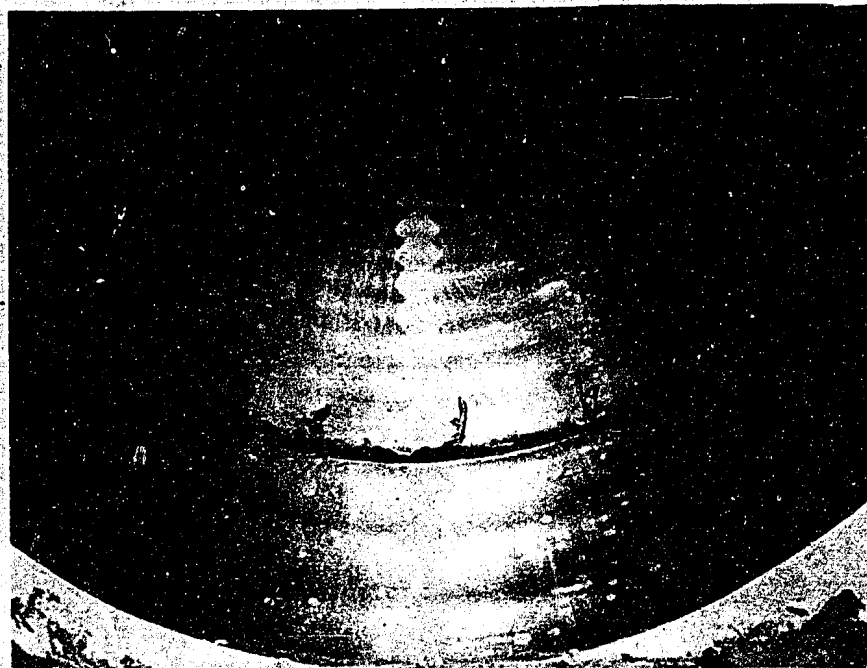
**B. View of joint looking downstream total test  
time 30 hours**

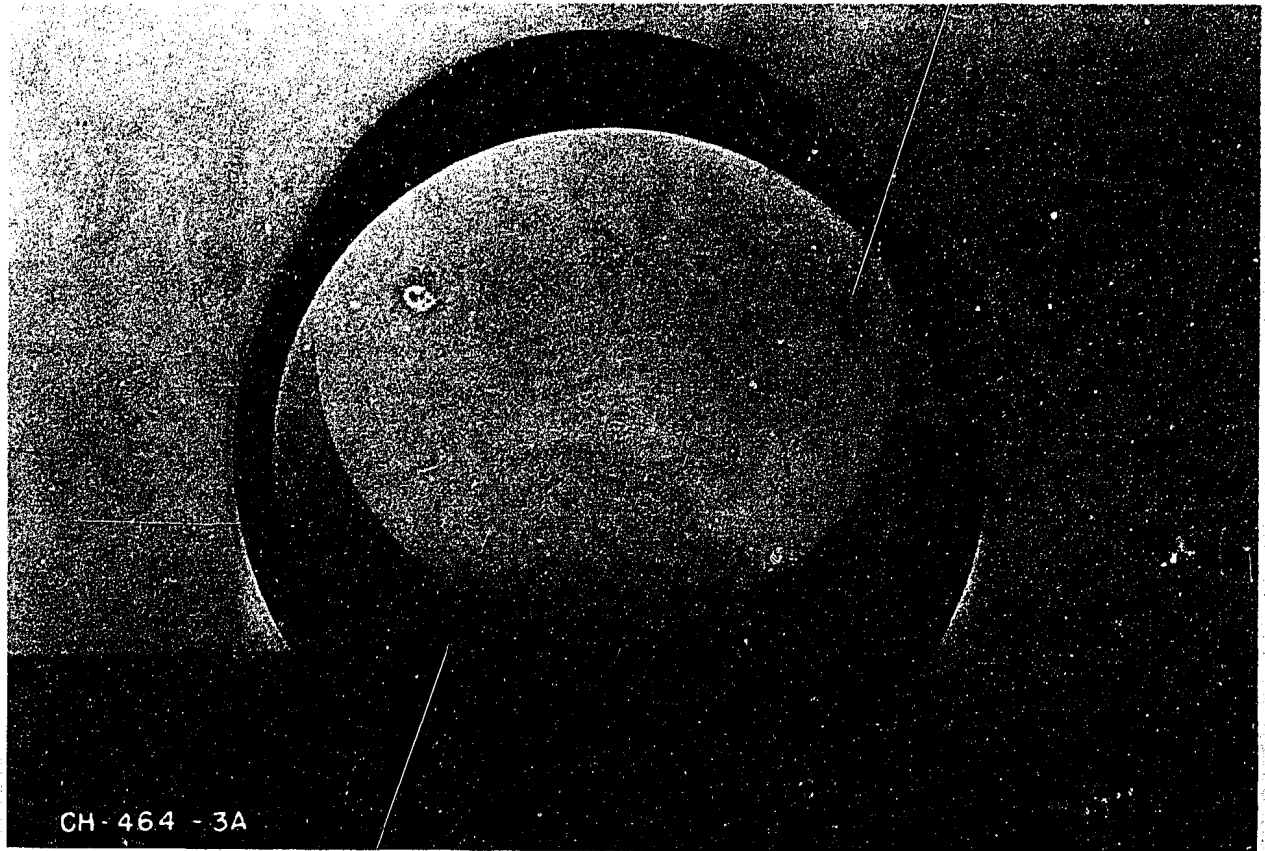
Photograph No. CH-464-3A. Showing the pipe before the abrasion test was started. The holes and craters are not typical of the usual application.

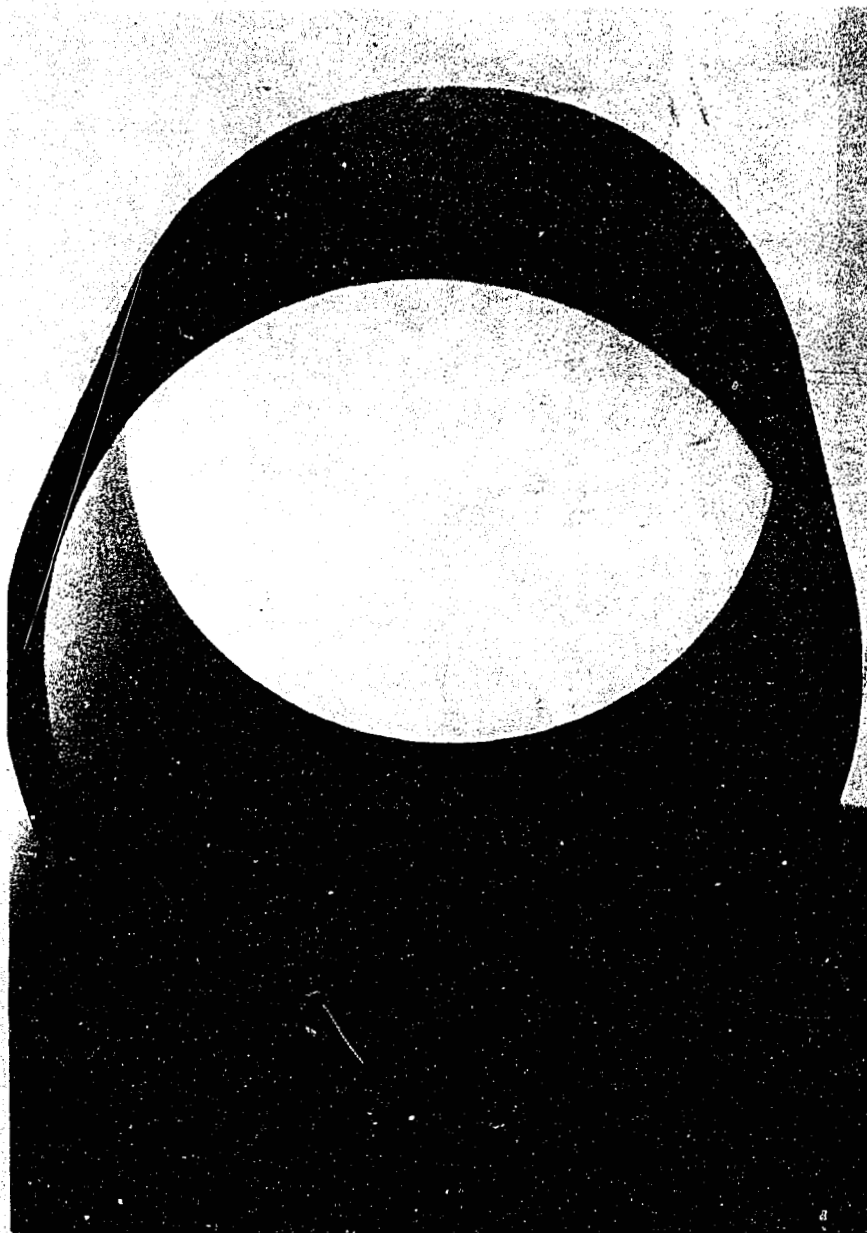
The appearance of the asphalt surface, however, has changed considerably as may be noted by comparing Figure 9 taken before the abrasion test was started with Figure 10 taken after 660,000 revolutions (2 weeks) at 33 rpm and Figure 11 taken after an additional 660,000 revolutions at 33 rpm and 660,000 revolutions at 97 rpm and Figure 12 taken after an additional 2 weeks (660,000 revolutions) at 33 rpm using No. 4 aggregate instead of sand. In the Figure 12, note in particular the pronounced rippling effect caused by the No. 4 aggregate as compared with the effects of the sand shown in the preceding photographs. It should be noted that the craters showing in Figure 9 are not typical of the application on the pipe furnished by Armco. As shown in the photographs, the surface has been roughened considerably and has embedded in it grains of sand. The asphalt is very soft, 46 penetration as compared with 15-20 penetration for American Water Works Association coal-tar enamel, which no doubt accounts for the effect caused by the sand.

Photograph No. CH-464-9. Note the general roughening of the surface after 660,000 revolutions at 33 rpm, using sand as the abrasive medium.
